174 Bosworth Creek (NWT)
Literature Review

October 2009

Environmental Studies Research Funds
Report No. 174

Bosworth Creek (NWT) Literature Review

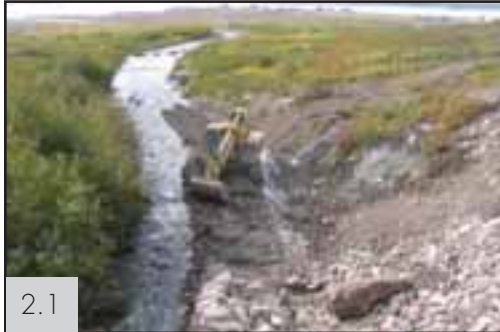
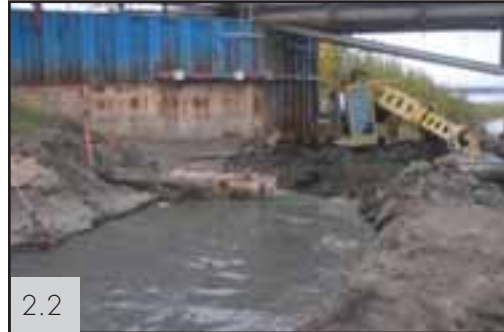
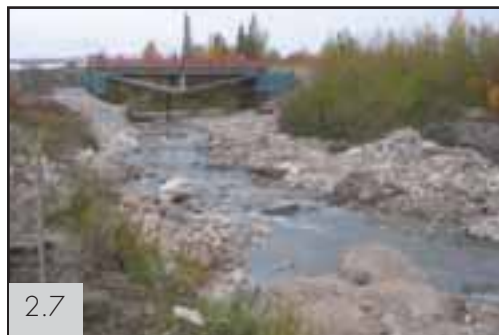
FIGURES 2-1 THROUGH 2-7
PRECISION GRADALL WORK ON BOSWORTH CREEK

Several pictures of works around the weir area on Bosworth Creek were located and are shown in Figure 2-1 through Figure 2-7 (Precision Gradall 2008). These pictures document the re-contouring of Bosworth Creek and show that efforts were made to stabilize the banks and mitigate erosion through placement of rip-rap and gravel along the shore, either during re-contouring, or as part of the weir construction and/or decommissioning. From Figures 2-6 and 2-7, it appears that during re-contouring, the creek was modified including the creation of several riffles.

Dismantling of the weir was initiated in the fall of 2004 and completed in 2005. Following removal, a project was initiated to re-contour the bed and banks of Bosworth Creek to allow fish (specifically arctic grayling) access to traditional spawning areas upstream of the lower Bosworth bridge (Imperial Oil Resources 2005). An engineering design was developed to facilitate fish movement by re-contouring the creek bed to a slope of approximately 30. This 30 grade represented a lower-angled creek-bed than the historic grade based on earlier engineering diagrams (Imperial Oil 2005). Hydraulic analysis of the rehabilitated stream was conducted to determine the capacity of the creek and the flow velocities during high flow. Flow velocity below the bridge was calculated to be on the order of 2.3 m/s. Flow velocities in the pool area ranged from approximately 2.6 to 2.8 m/s depending on proximity to rocky outcrops. Flow velocities in these areas were approximately 3.1 m/s. Further details of the water management techniques, design modifications, construction work, final survey and hydraulic analysis are given in Komex 2005. At the request of DFO, Streamworks Unlimited was asked to provide advice on the channel and bank stabilization with respect to long term fish habitat and passage (Bates 2005). There were some initial concerns such as the placement of large boulders at 5-m spacing along each bank as potential resting places for fish. It was felt that these boulders may not be adequate at higher flow conditions for fish spawning. Modifications were suggested to the earlier surface design, and included the construction of three riffles and pools along the channel which would improve stability by dissipating energy, and provide areas for fish resting and holding. The three riffles were placed approximately 30-m apart and constructed to be about 0.9-m in height, allowing each riffle to backwater the toe of the next riffle upstream.

In summary, a relatively stable bank section with good opportunities for fish passage at a range of flows was created downstream of the bridge over Bosworth Creek. Still, it remains unclear whether the channel has been monitored for fish passage successes or spawning activities (Bates 2009). A report was prepared for DFO on the weir removal which included a summary of proposed engineering activities; however, there were no biological studies proposed (Imperial Oil 2004).
